# Inspection Report

## Visionary Holdings

372 Altamont Ave  
Fort Myers FL 33905

## MEF Home Inspections LLC

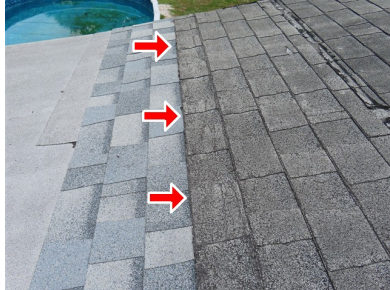
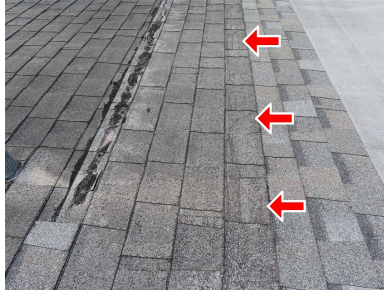
**Seller has fixed all items on this page; roof company said the crease is not a leak hazard or problem**

(1) The roof had creased and broken shingle tabs typical of wind damage. Damaged shingles be replaced to help prevent damage from moisture intrusion to the home materials, the roof structure and to prevent development of microbial growth such as mold. This type of damage is typical of asphalt shingles that are poorly bonded. You may wish to consult with a qualified contractor to discuss hand-sealing any poorly bonded shingles to avoid or minimize future wind damage.

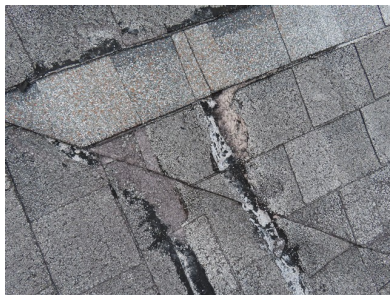
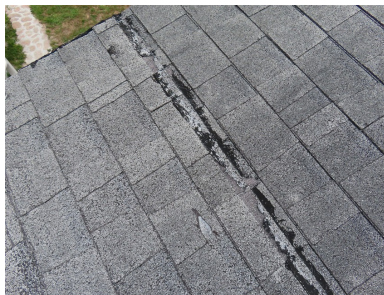
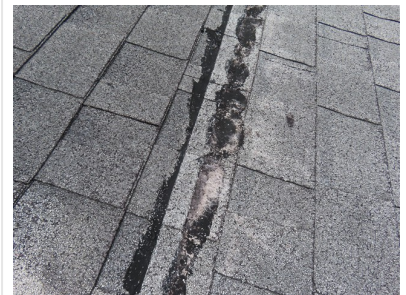
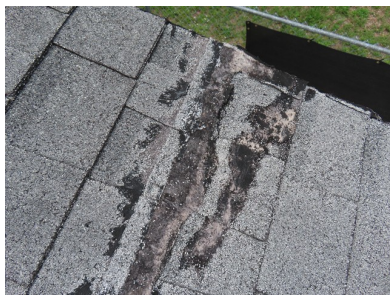
(2) The roof had areas of damaged shingles with exposed fiberglass mass and asphalt. Shingles should be replaced by a qualified roofing contractor.

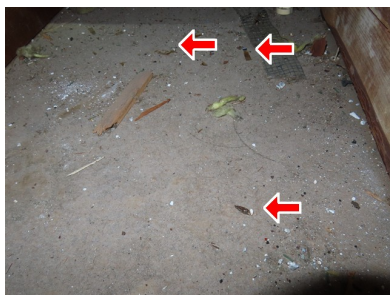
2.6 Item 1 (Picture)

(1) Inspector observed evidence of rodent droppings in attic. Inspector recommends further evaluation and treatment by a qualified pest contractor.

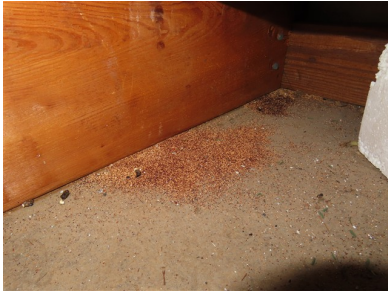
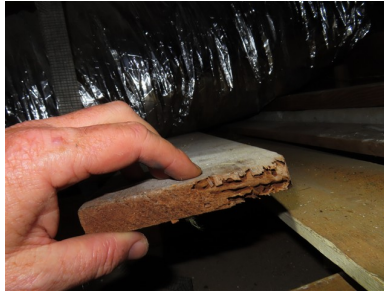
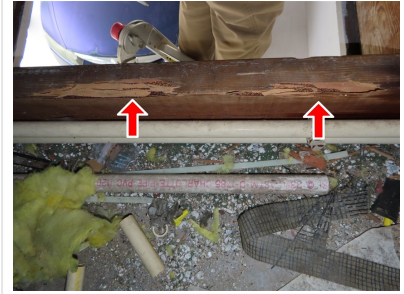
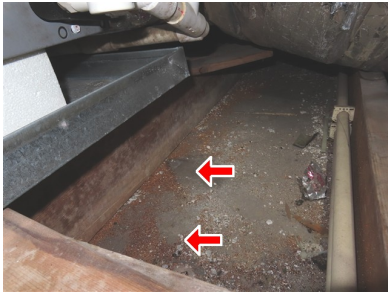
(2) Inspector observed evidence of termite frass in the attic at time of inspection. Inspector recommends further evaluation and treatment by a qualified pest contractor.

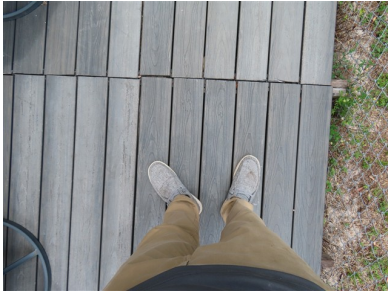
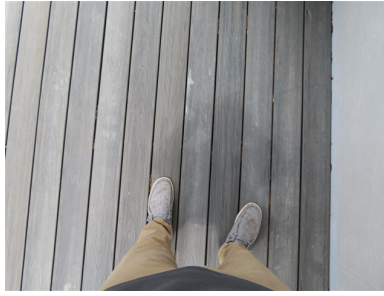
Deck planks on left side of dwelling were soft when walked on. Damaged planks should be replaced by a qualified contractor.

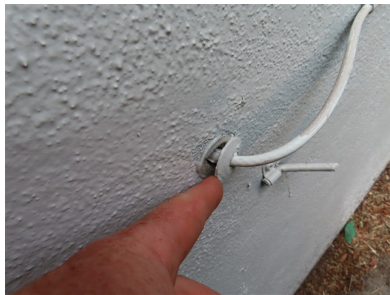
(1) Exterior wall penetrations had gaps that should to be sealed with an appropriate sealant to prevent moisture and insect entry. All work should be performed by a qualified contractor.

**5.2 Item 1 (Picture)**  
Front side

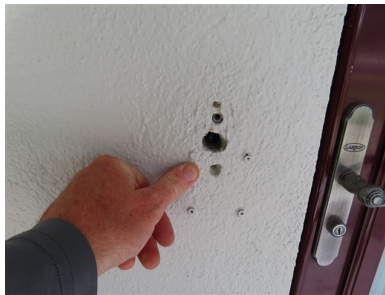
**5.2 Item 2 (Picture)**  
Near front door

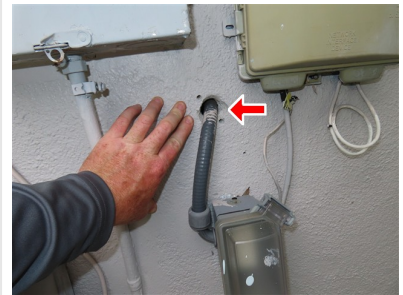
**5.2 Item 3 (Picture)**  
Rear

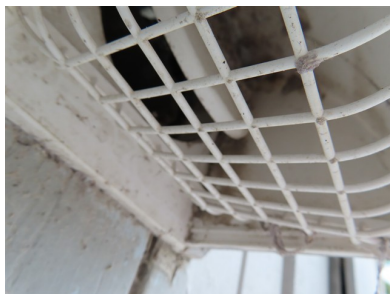
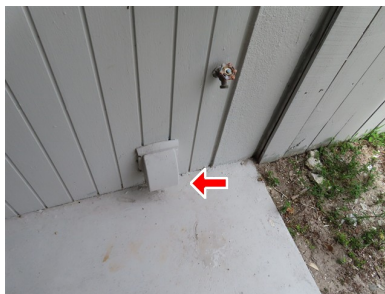
(2) Where the dryer vent terminated at the home exterior a screen was installed over the vent opening. This condition may trap lint, interfering with exhaust airflow, with the potential to cause dryer overheating that is a potential fire hazard. The screen should be removed and the vent brought into a safe condition by a qualified contractor.

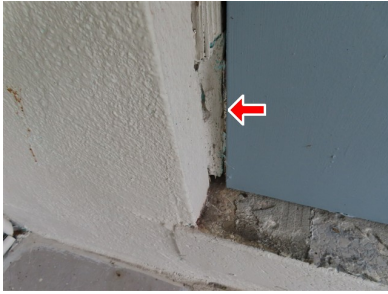
**5.3 Item 1 (Picture)**

The door trim at rear porch had advanced decay visible in areas. The inspector recommends replacement as necessary by a qualified contractor.

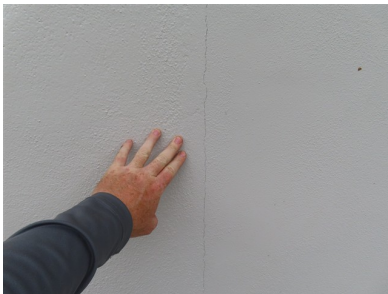
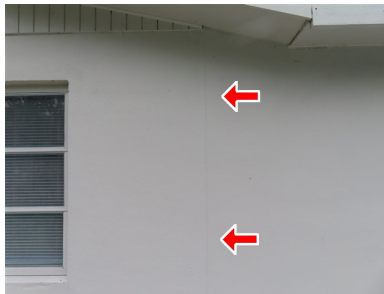
Vertical cracks in stucco covering the exterior walls of the home were located where an addition connects to the home. This condition can have several causes, including differential settlement between the addition and main home structure, or differing thermal expansion and contraction rates of substrate materials. Cracks exceeding 1/16-inch in width should be filled with an appropriate material to prevent future damage from moisture and monitored in the future for continued activity.

**5.4 Item 1 (Picture)**  
Rear

**5.4 Item 2 (Picture)**  
Rear

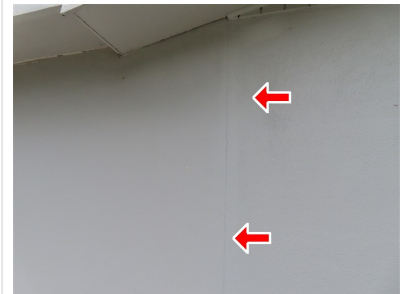
**5.4 Item 3 (Picture)**  
Left side

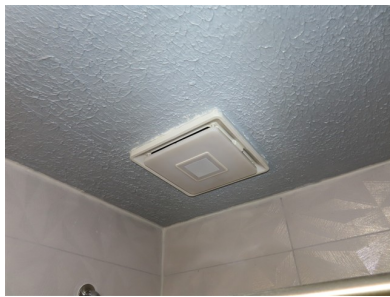
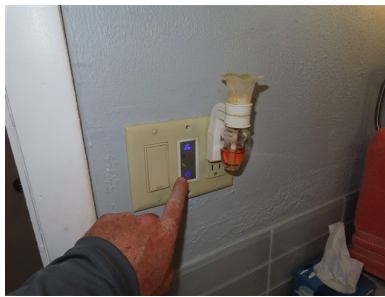
Exhaust vent in the 1st shared bathroom was inoperable at time of inspection.

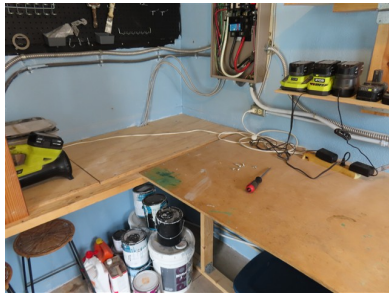
10.6 Item 1 (Picture)

The service panel cabinet had inadequate working clearance in front. Modern safety standards require a minimum open space 30 inches in width for a height of 6 feet-6 inches. Minimum clearance in front of the cabinet should be 3 feet. The Inspector recommends correction by a qualified contractor.

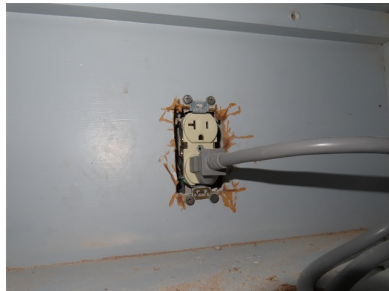
10.12 Item 1 (Picture)

(1) An electrical receptacle cover plate was missing in the kitchen above microwave. This condition left energized electrical components exposed to touch, a shock/electrocution hazard. The Inspector recommends a cover plate be installed by a qualified electrical contractor. **Item has been repaired**

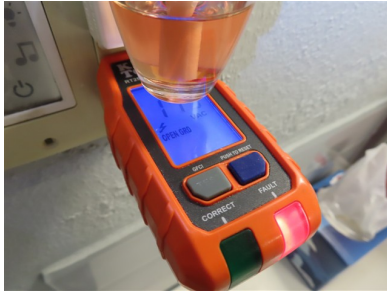
10.12 Item 2 (Picture)

(2) An electrical receptacle at the 1st shared bathroom had an open ground. The Inspector strongly recommends evaluation and correction as necessary by a qualified electrical contractor.

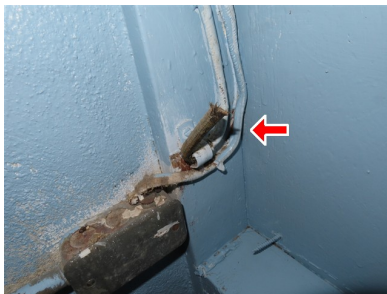
10.15 Item 1 (Picture)

(1) Exposed wiring present at laundry room. Inspector recommends having an electrician determine if wires are hot, and to terminate wire into an appropriate UL listed junction box.

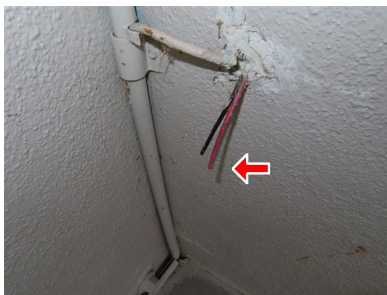
10.15 Item 2 (Picture)

(2) Exposed wiring present at rear side of dwelling. Inspector recommends having an electrician determine if wires are hot, and to terminate wire into an appropriate UL listed junction box. **Item has been repaired**

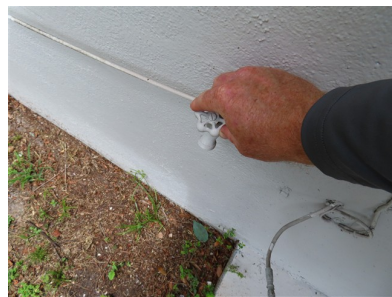
**11.0 Item 1 (Picture)**

A hose bib near the front of the home was inoperable.

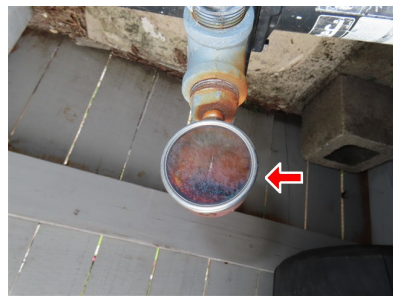
11.4 Item 1 (Picture)

(1) Gauge for well pump exhibited signs of severe deterioration.

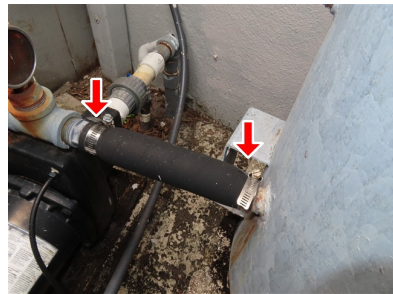
11.4 Item 2 (Picture)

(2) At the well pump, improper piping was used to connect pump to expansion tank.

(2) A the well pump, improper piping was used to connect pump to expansion tank.

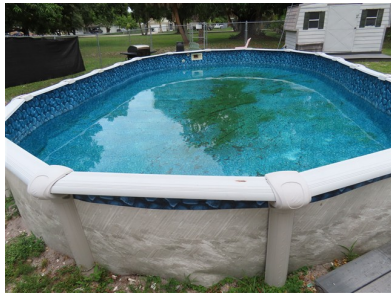
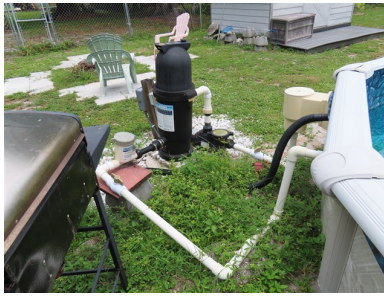
The pools water level was to low to operate pump and filter. Inspector only did a visual inspection of vessel, and pool equipment.
